A Phase-by-Phase Approach in Developing Hybrid and Nature-Based Coastal Protection Measures Alongside Municipalities Influenced by Changing Winters – A Preliminary Case Study in NB’s Acadian Peninsula

Christopher Mea, EIT
June 2025

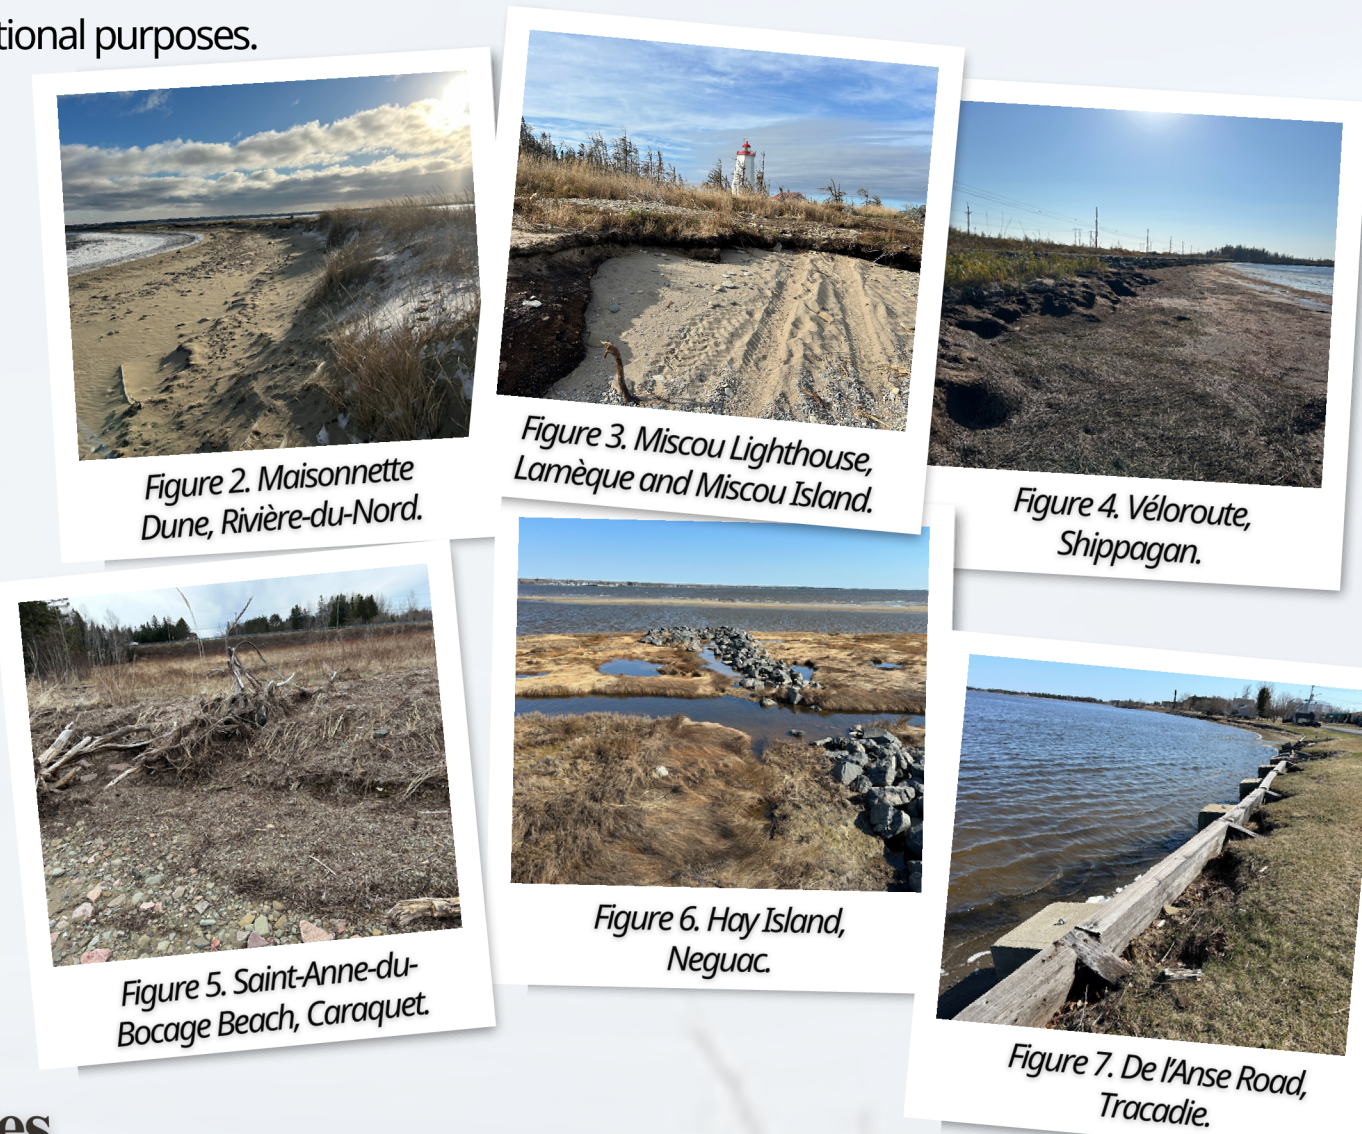
Municipality	2 - Lamèque/Miscou	Score	4.67
# Site	2.5	Site name	Phare de Miscou
ANALYSIS			
Stakes	Strong	Necessity	Very Strong
Erosion Risk	Very Strong	Accessibility	Very Strong
Flooding Risk	Strong	Visibility	Very Strong
COMMENTS			
Description and comment:	Highly touristic location during summer, of great cultural and economic importance. An armour stone revetment is already present in front of the lighthouse, but the dunes on each side are exposed to force of waves from the Gulf of Saint Lawrence. The higher energy level on this site leads to greater waves and erosion and flooding risks.		
Conclusion	The visibility and importance of the site, in addition to the regional stakes and risks, greatly increase the need for intervention. Scour around the existing armour stone is worsening and the site is particularly vulnerable to sea level rise.

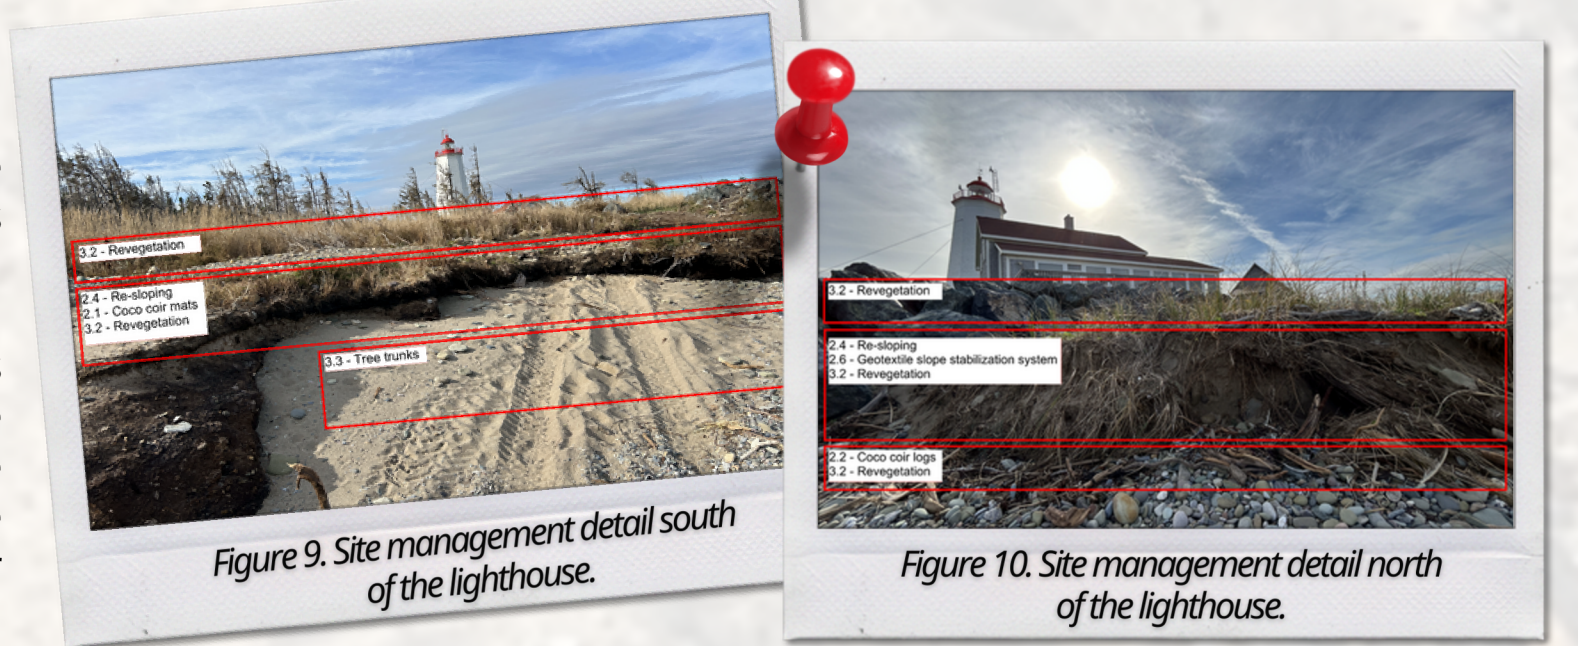
On larger overview plans, numbered measures are identified in target areas following recommendations, as areas of greater concern may have different needs and may require other, more suitable measures. Site details and photos are referenced on the plan for added context.
